Report at CGA Seminar “Safety and Reliability of Industrial Gases, Equipment and Facilities”, October 15 - 17, 2001, St. Louis, Missouri

Nitrous Oxide Trailer Rupture July 2, 2001

Konrad Munke
Linde Gas AG
Seitnerstrasse 70,
D 82049 Höllriegelskreuth

Medical gas plant in Eindhoven, The Netherlands

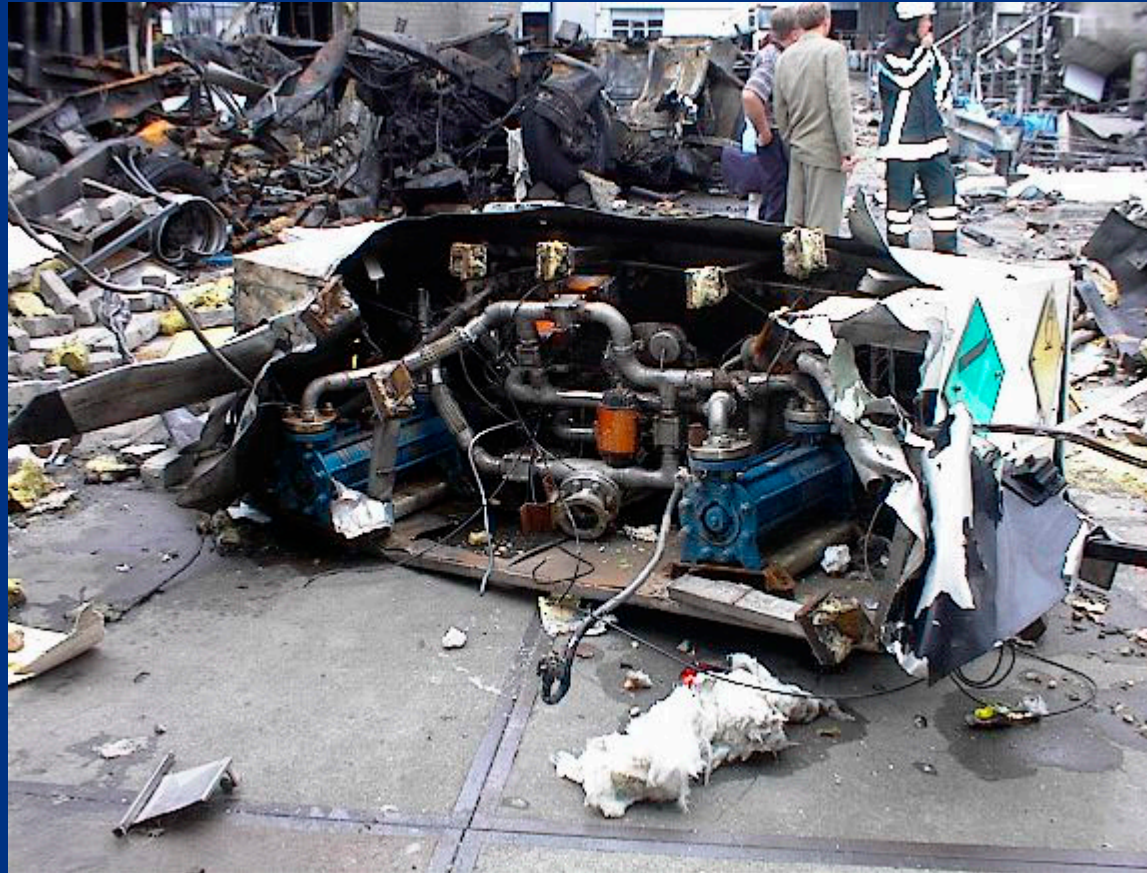
Pumps and piping of the trailer

- The pump was not cooled down. It was running dry.
- The end of the pump shaft at the pressure side had significant annealing colour, generated by heat.
- The bearing box at the pressure side had blisters in the lacquer coating, generated by heat.
- Several of the bearing bushes, made of carbon, were damaged and - possibly - particles of it were burnt.

Nitrous oxide pumps shall be equipped with dry running protection, e. g. by control of temperature, differential pressure and/or engine power.

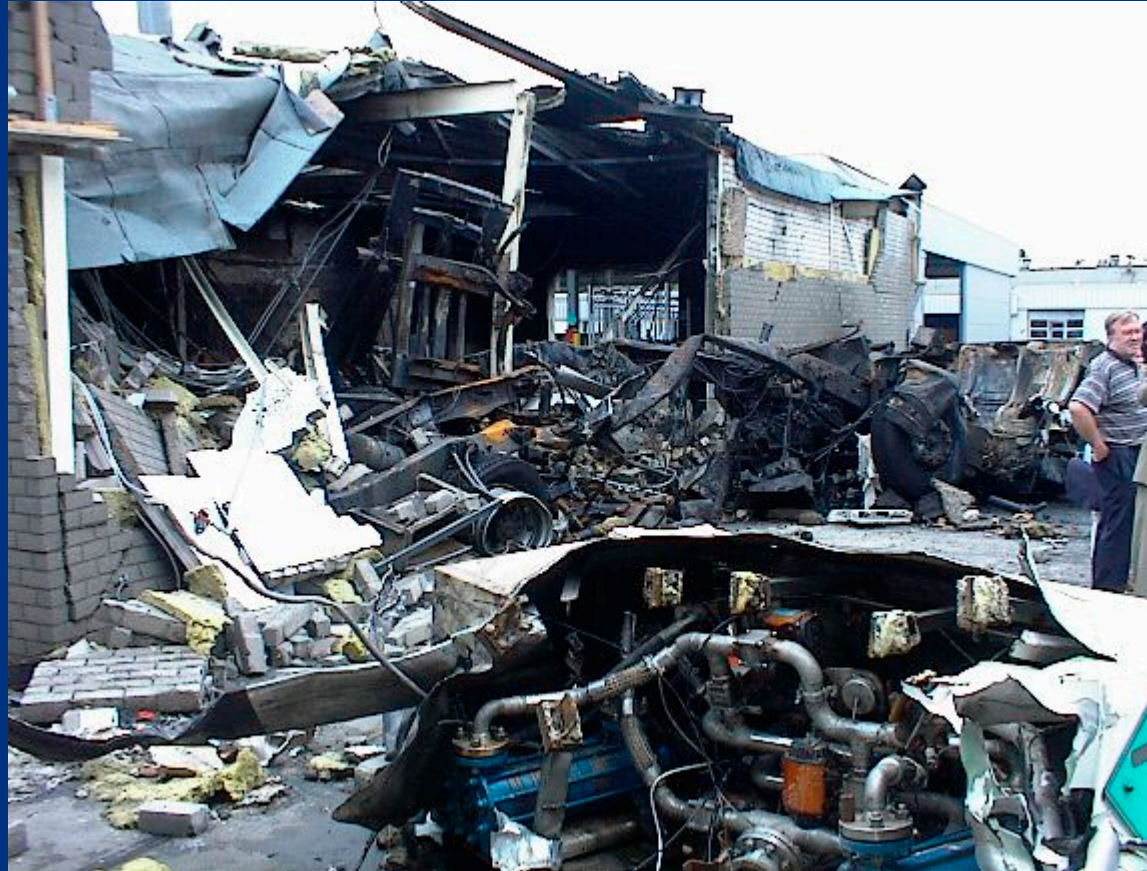
Trailer tank: Man hole cover torn off, tank shattered in two big fragments which were thrown away by 50 meters or 400 meters respectively.

Fragments of the trailer

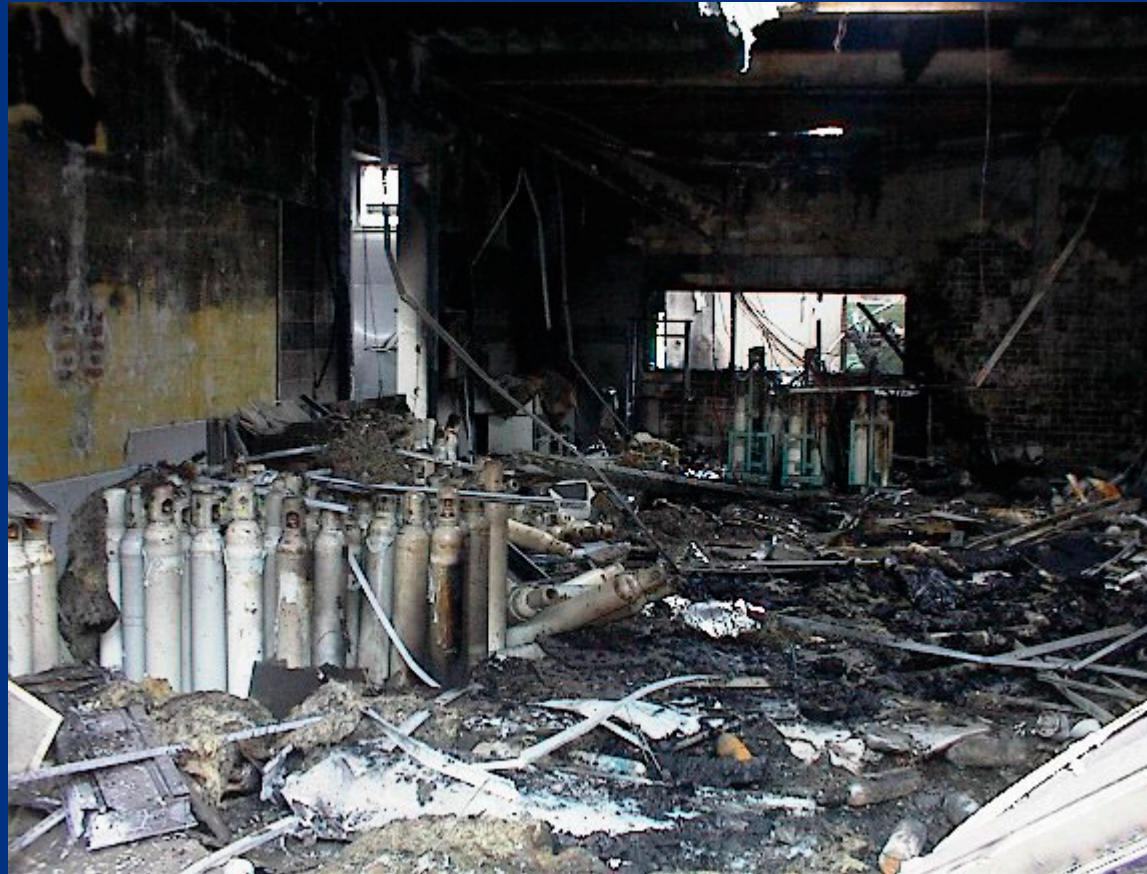
Strong fire developed, fed mainly by diesel fuel, promoted by nitrous oxide and oxygen which was set free from bursting cylinders.

Fire in the filling hall

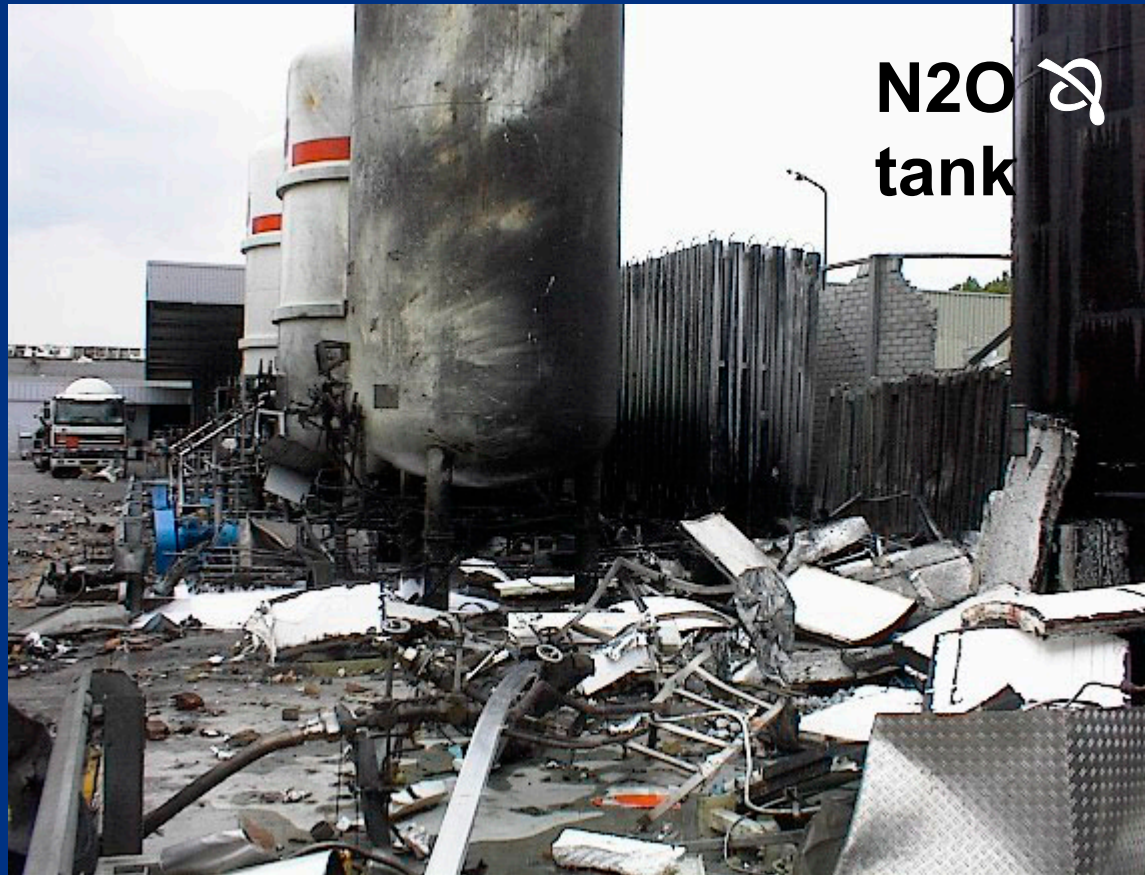
Storage tank: Pushed away by 3 meters but stayed in its upright position, piping torn off, whole content spilled.

N₂O storage tank on the right hand side

Prior to the incident the N₂O tank was in straight line with the other tanks

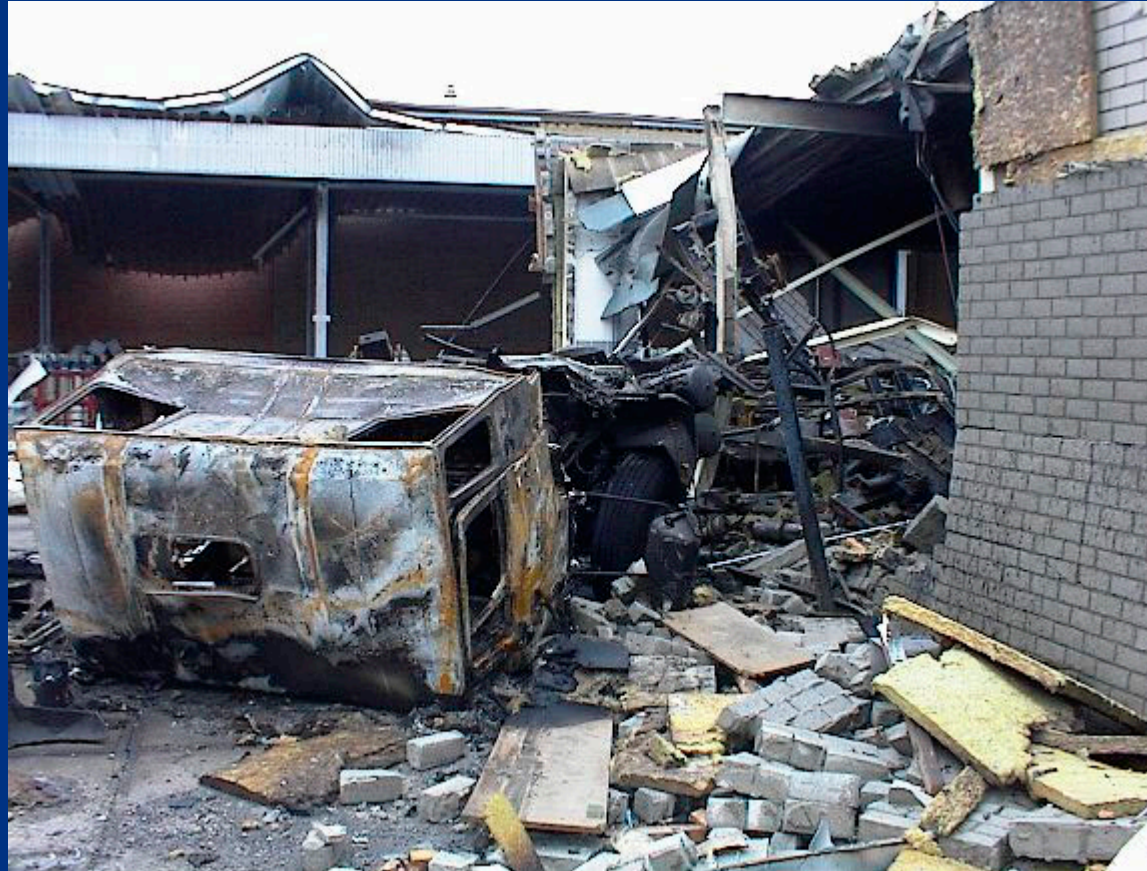
Driver cabin of the trailer

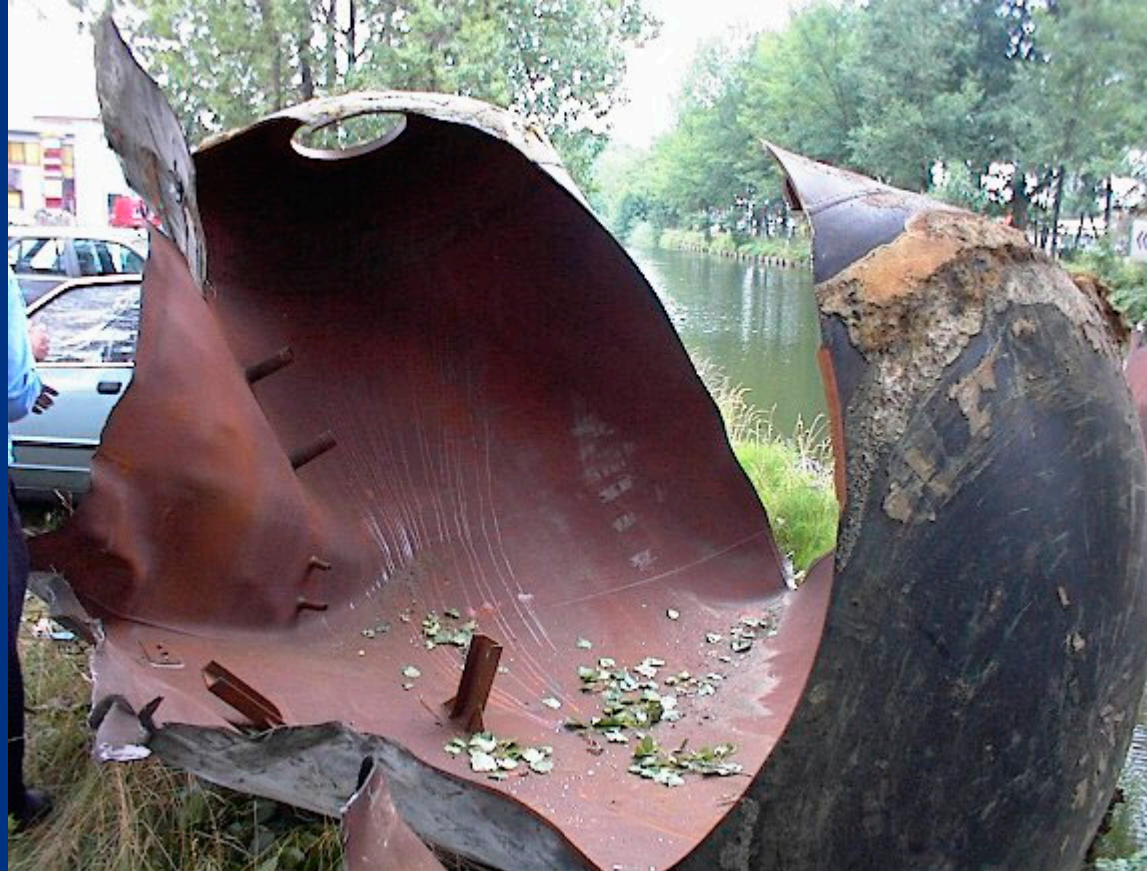
Fragment of the ruptured tank
